Technical Report C-13

Methodology And Effectiveness Of Drainage Systems For
Airfield Pavements

November 1974

Harry R. Cedergren

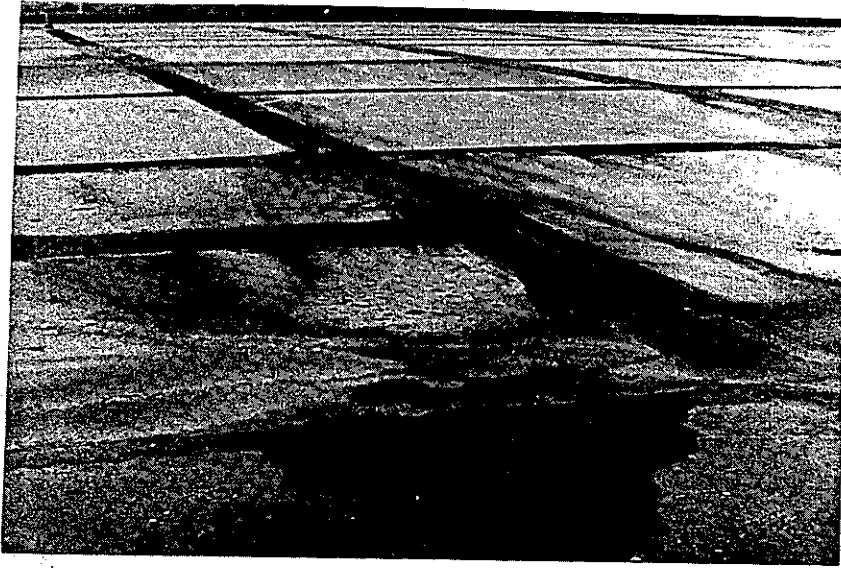
Figure 2. Photo of a poorly drained PCC pavement that has been severely damaged by excess water, and extensively repaired.

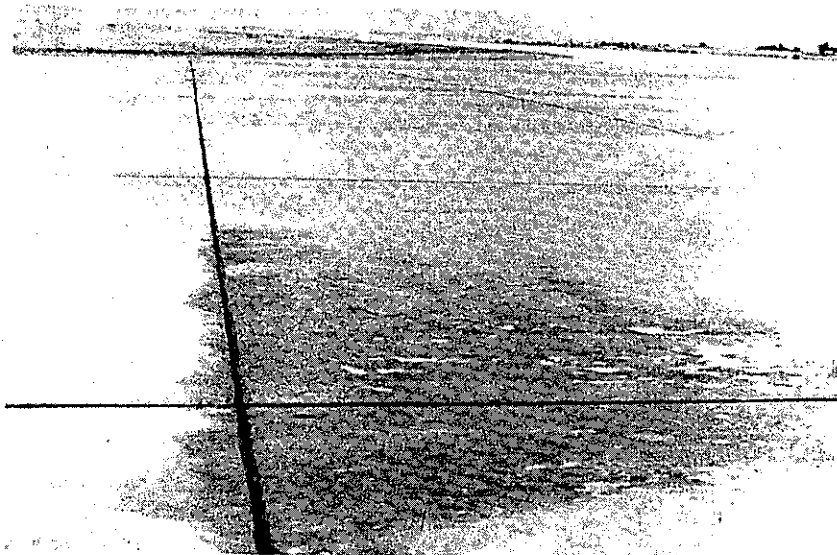
Figure 3. Photo of a poorly drained, heavy-duty PCC pavement in "semi-arid" climate; stains indicate possible bleeding or surging; no apparent physical damage yet.

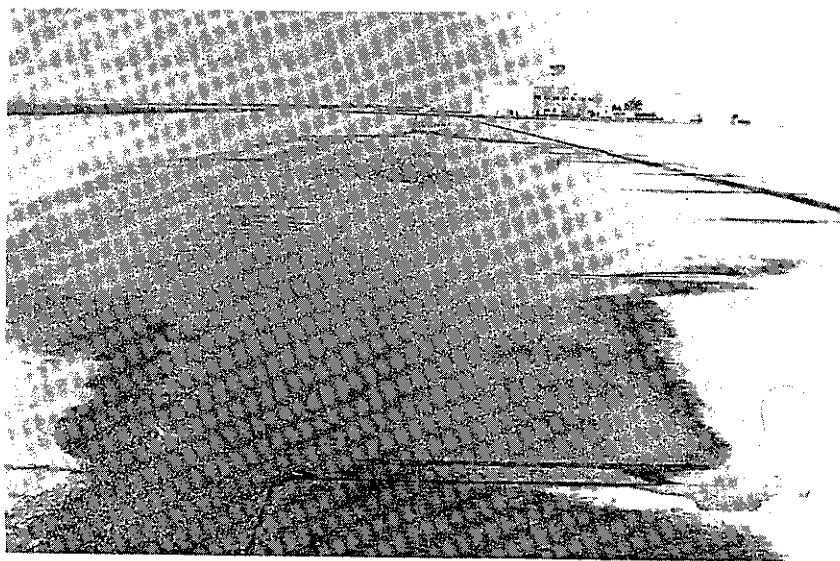
Figure 10. Photo showing large "birdbath" in a wide, flat pavement.

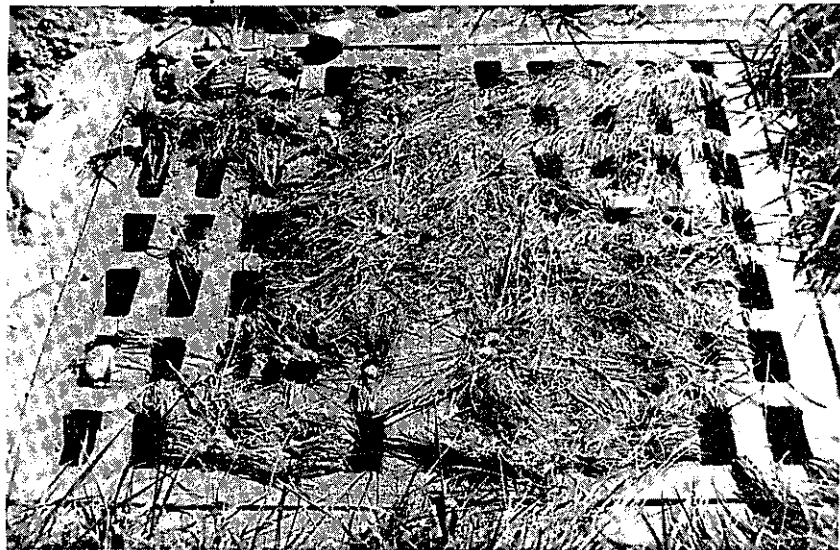
Figure 11. Photo showing common type of clogging nuisance at inlets; requires periodic cleaning by maintenance forces.

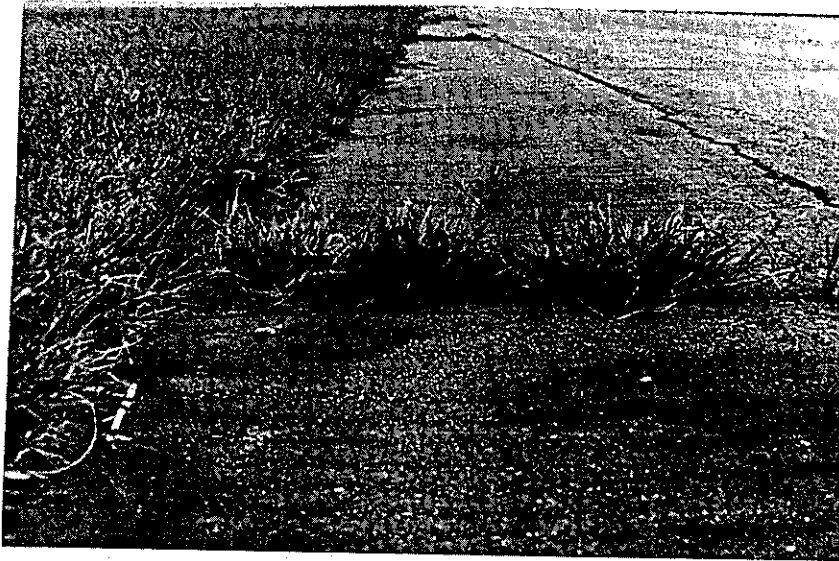
Figure 12. Photo showing high sod at the edge of a taxiway having poor subsurface drainage, and poor surface drainage at outer edges.

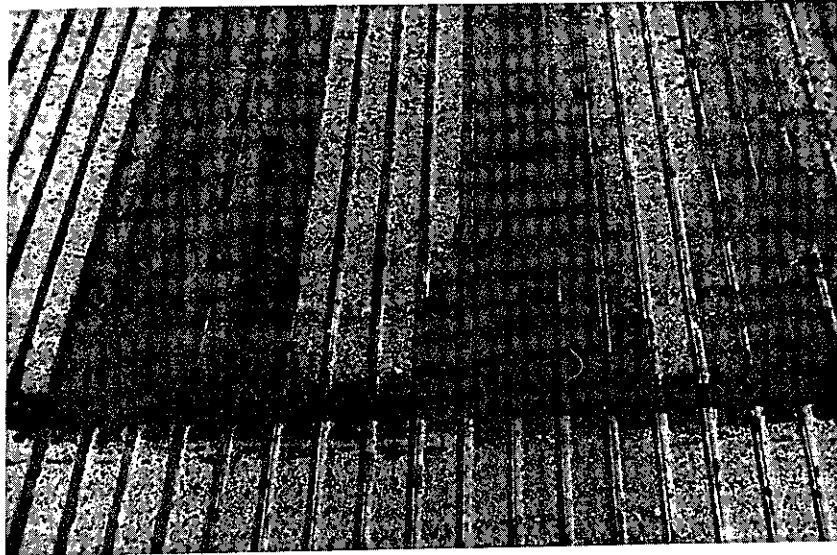
Figure 13. Photo showing diamond-grooved PCC runway; dark stains show that past inflows have entered the construction joint.

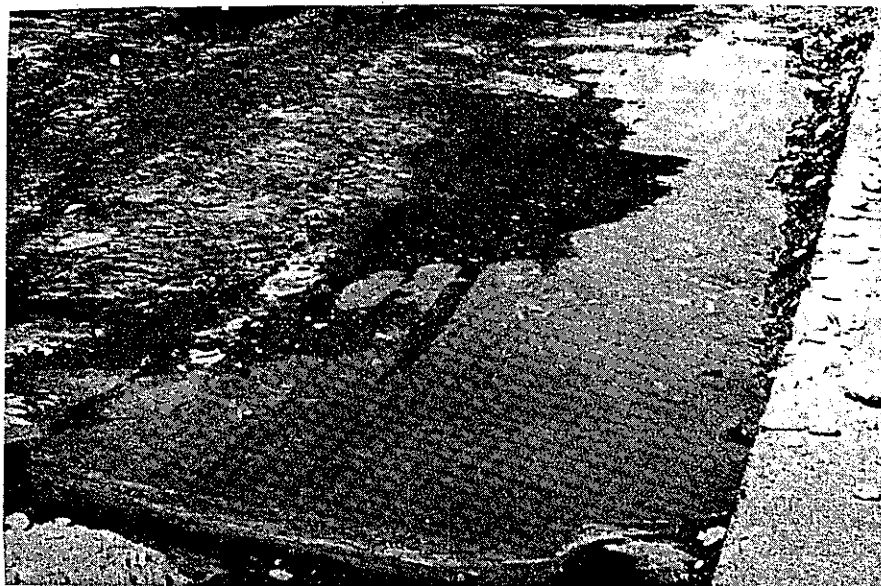
Figure 20. Photo showing water standing on base course during the reconstruction of a damaged taxiway; several days after a rain. Indicates slow drainage.

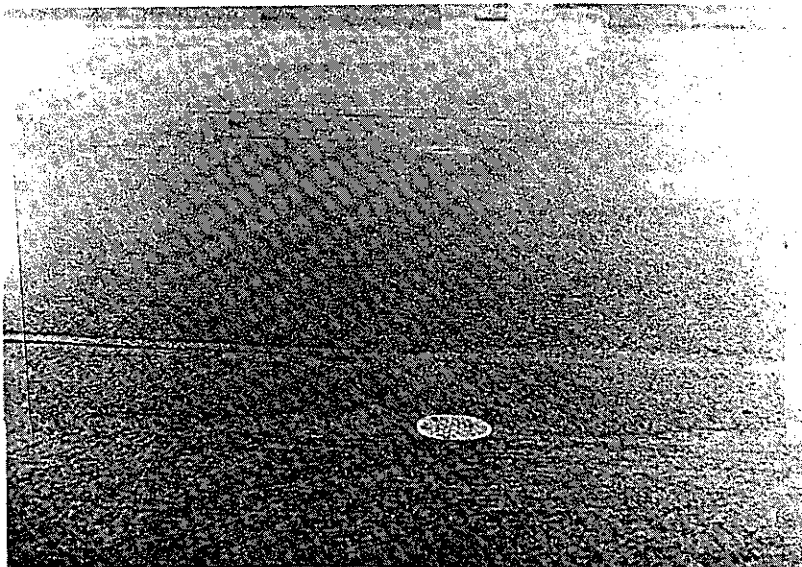
Figure B-10. Another poorly drained area where water collects during every rain; picture taken during a rain.

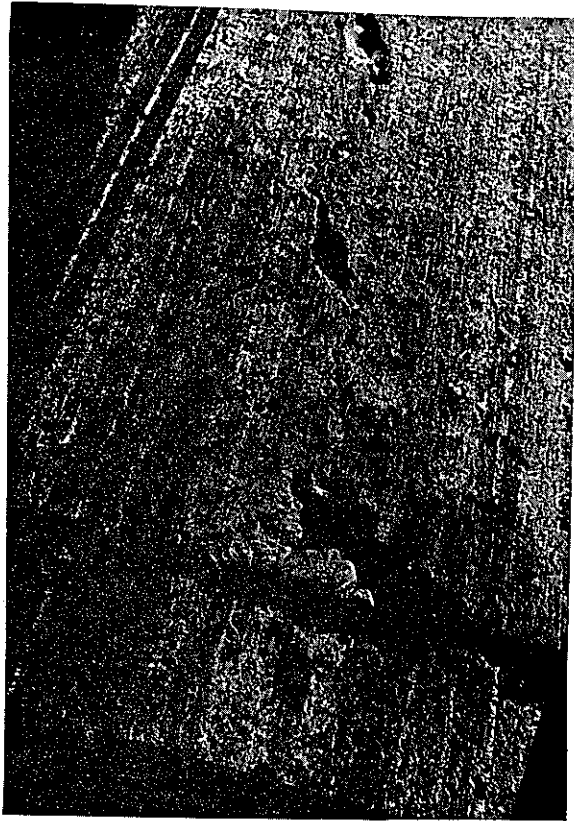
Figure B-11. A main runway; unsealed crack in 16-in. thick PCC pavement.

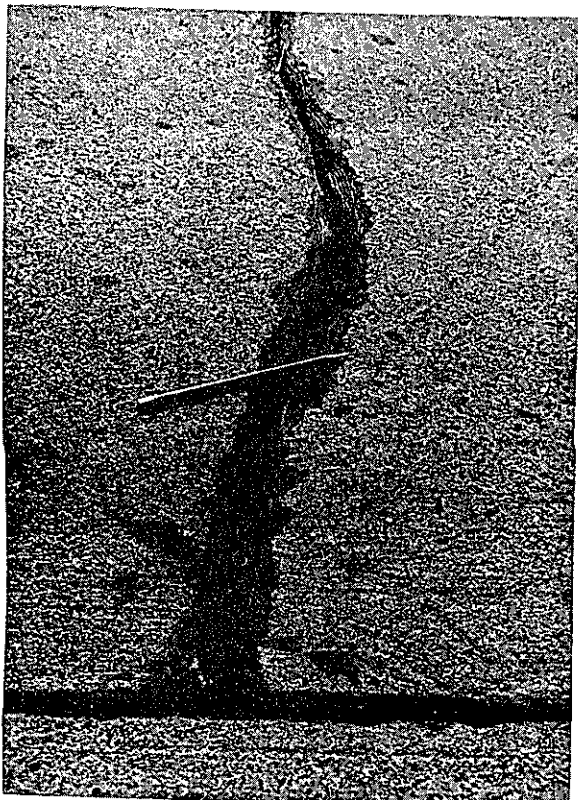
Figure B-12. Open, routed crack in an aircraft apron.

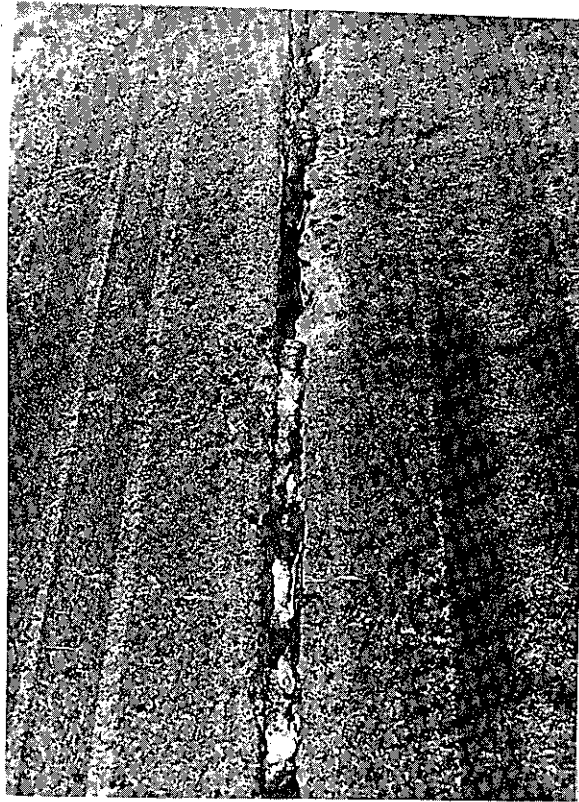
Figure B-13. Main runway; open cross joint with some spalling.

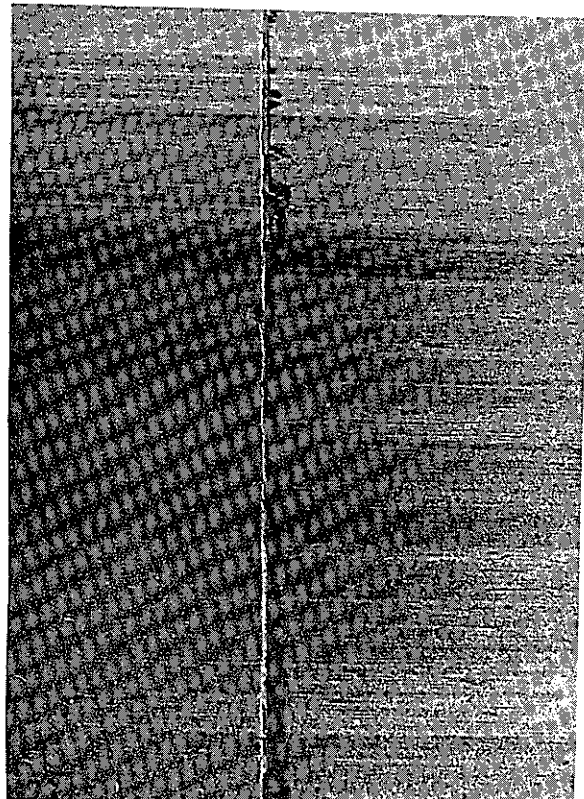
Figure B-14. A primary runway; cross view of an open joint.

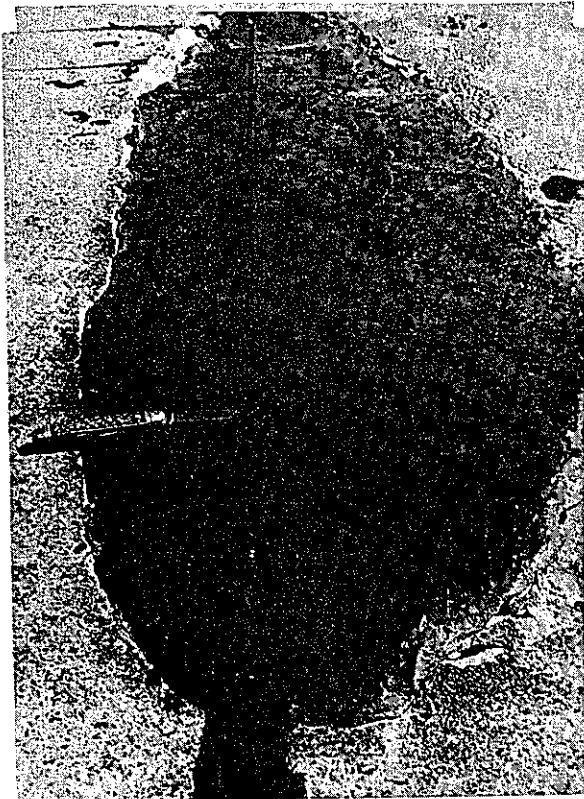
Figure B-16. Main runway; epoxy patch is breaking out; saw cut was very shallow (knife blade has dark stain at end which shows depth of saw cut to be about 1/3 inch).

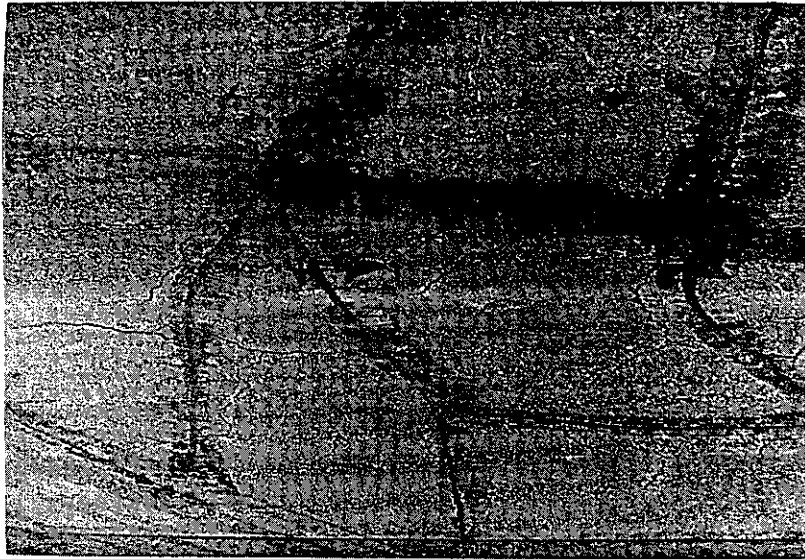
Figure B-17. A taxiway in a moderately heavy traffic area; wide cracks in AC have not yet been covered with a slurry seal.

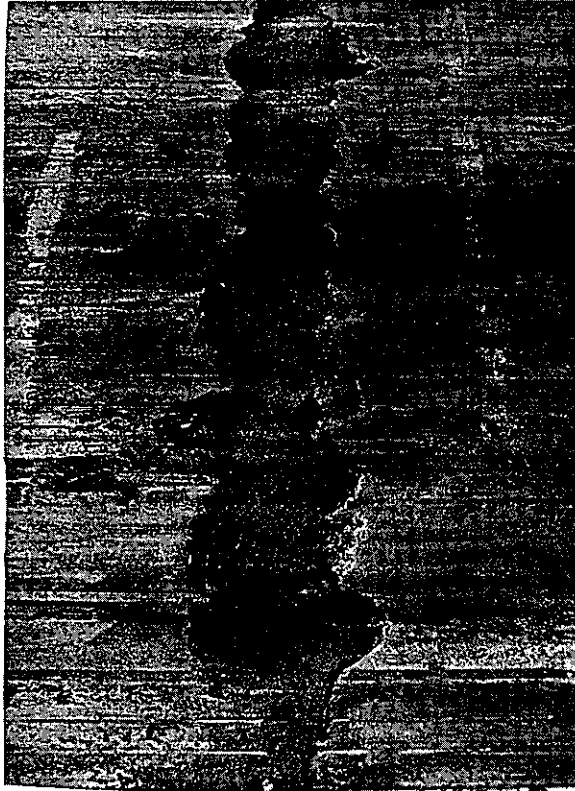
Figure B-18. A main runway; spalled area, about 18-in. wide at maximum; has been patched with AC; may have started as a joint problem, but is big enough to be of structural importance.

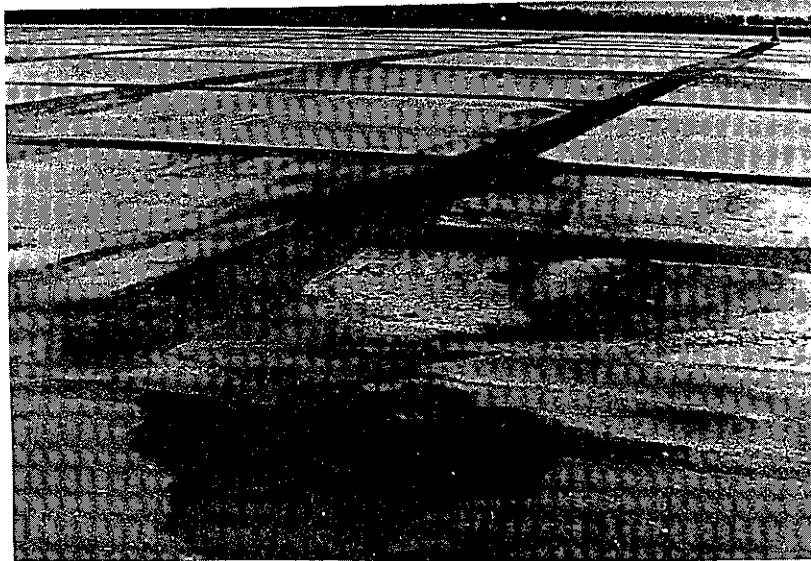
Figure B-19. Extensive damage of pavements; repair of joints has been required; much excess water and bleeding; free water coming out several days after a rain.

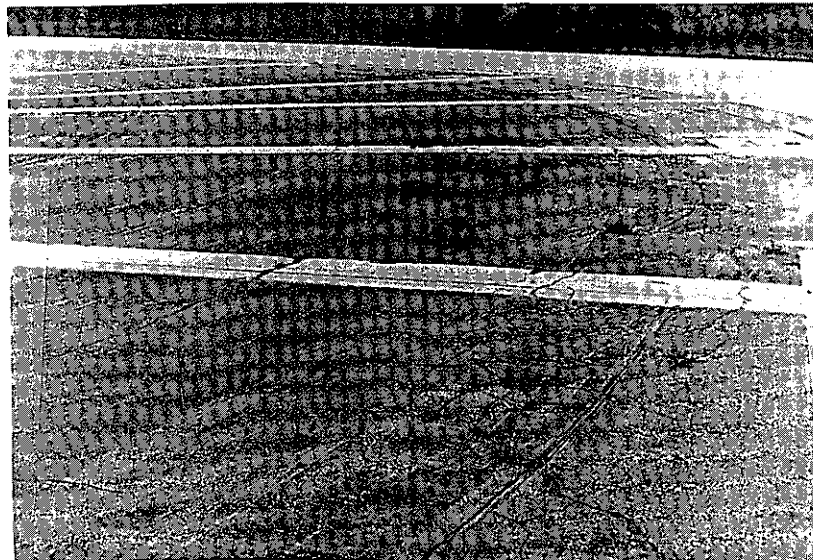
Figure B-20. Severe cracking of thin AC pavement in shoulder of a taxiway; believed due to frost action with liberal supply of water available.

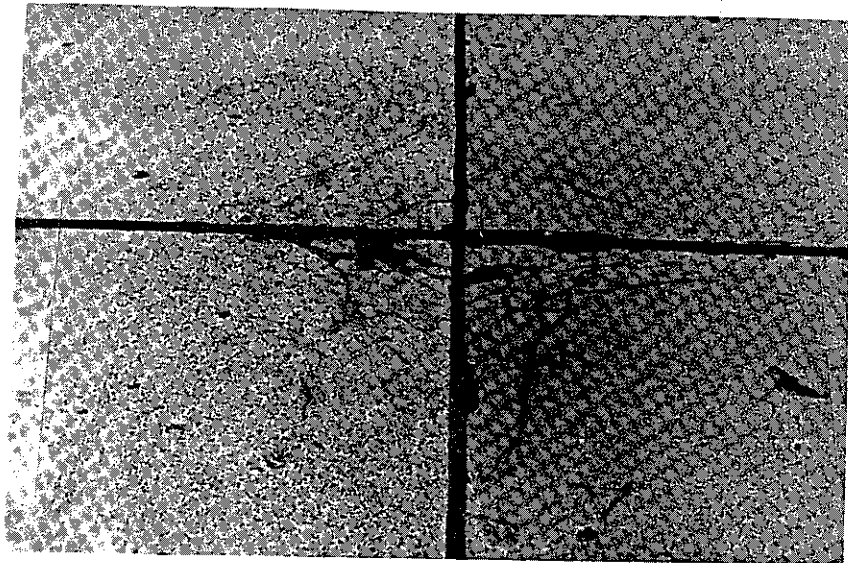
Figure B-21. Taxiway; typical corner "D" cracking in thick PCC pavement; 24"-27" section.

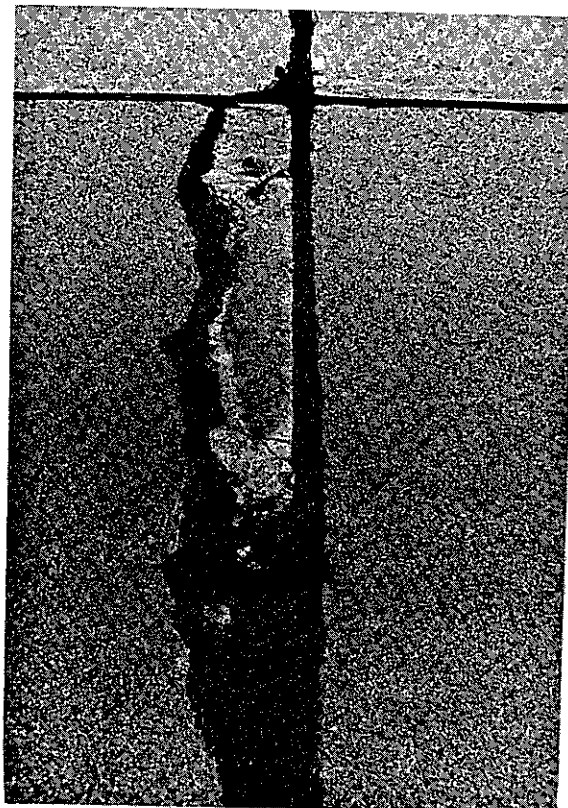
Figure B-22. Operational apron; repaired spall is breaking out; 11-in. PCC on 6-in. PCC and base course.

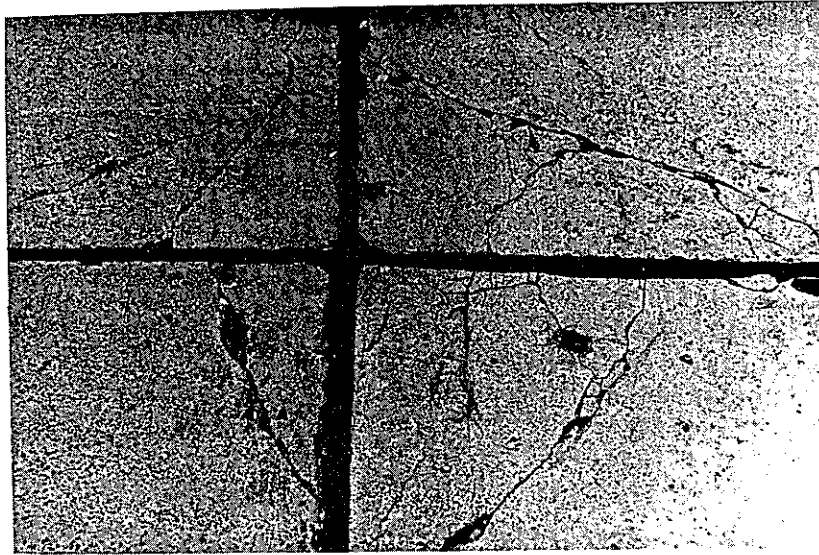
Figure B-23. Taxiway; "D" cracking at intersecting joints in heavy duty PCC pavement.

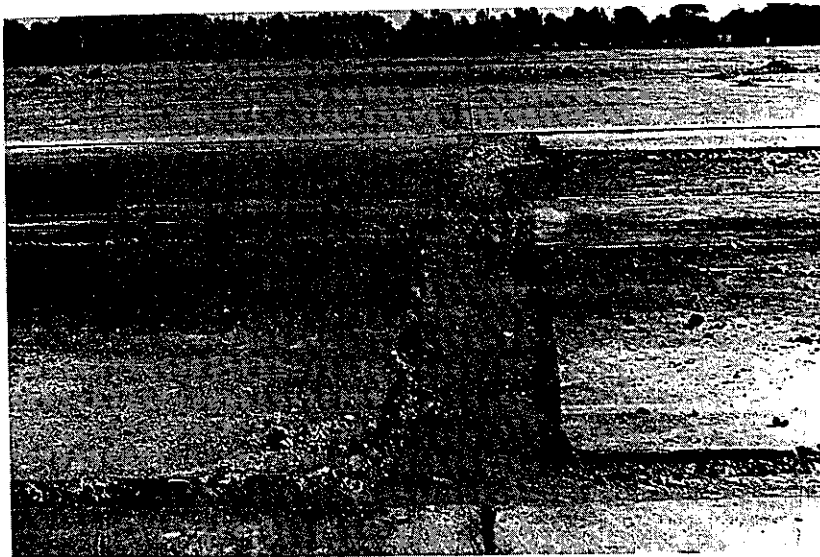
Figure B-24. Apron extension; deteriorated joints have been diamond-sawed and chipped, as part of joint repair and overlay contract.

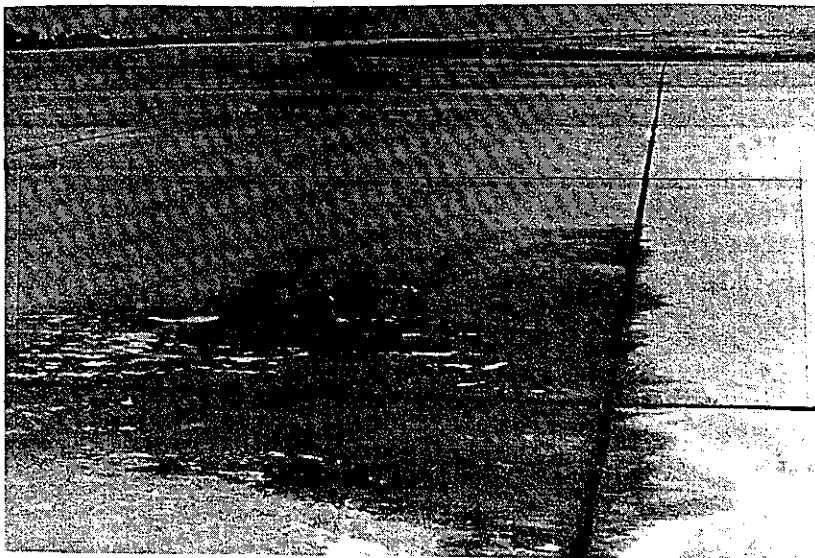
Figure B-25. Warm-up apron near the end of a runway; dark stains indicate possible surging area (water squeezed out by planes); warm-up apron at end of runway at taxiway.

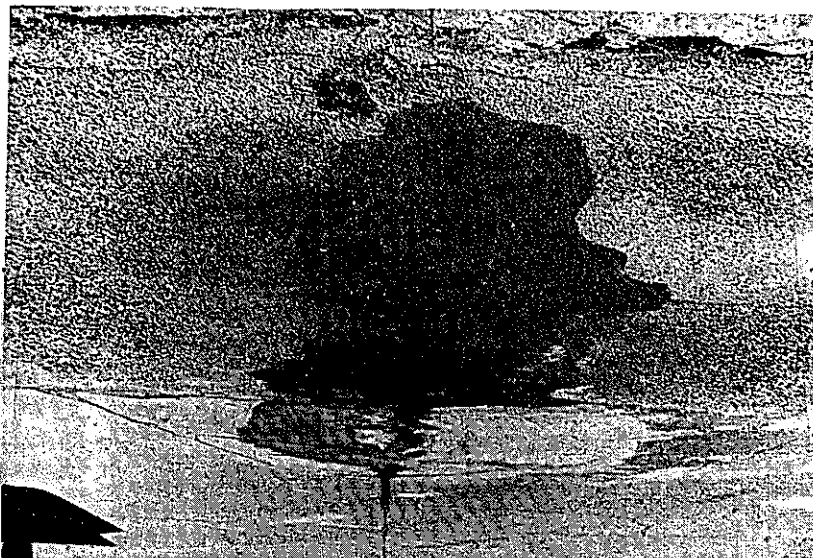
Figure B-26. Old runway, bad bleeding, much pavement damage from excess water.

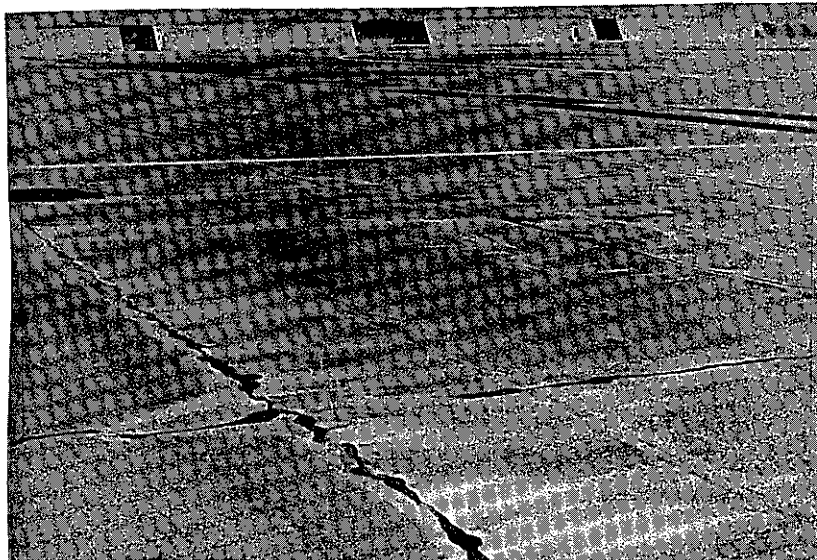
Figure B-27. Parking apron; excessive bleeding shows here; much patch work and joint repairing has been required.

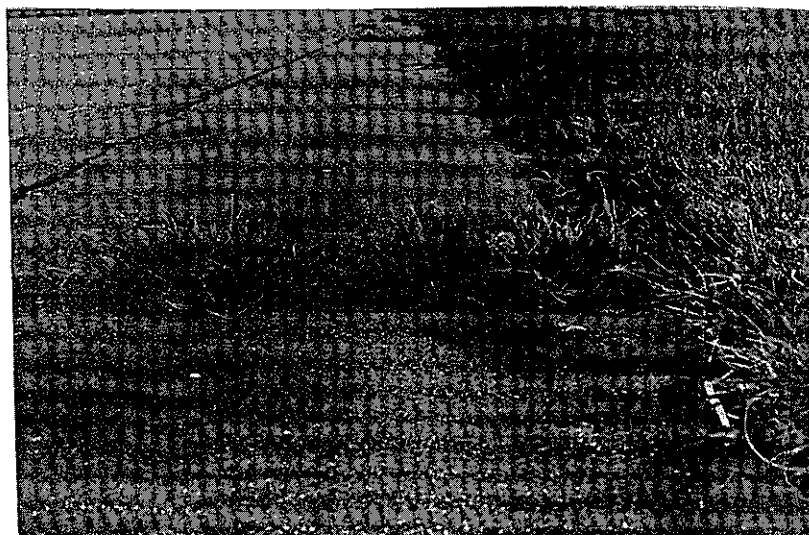
Figure B-28. Taxiway; high sod along edge; this is in a "bathtub" condition; profuse grass in cracks in AC is indication of plentiful water supply; a very common condition.

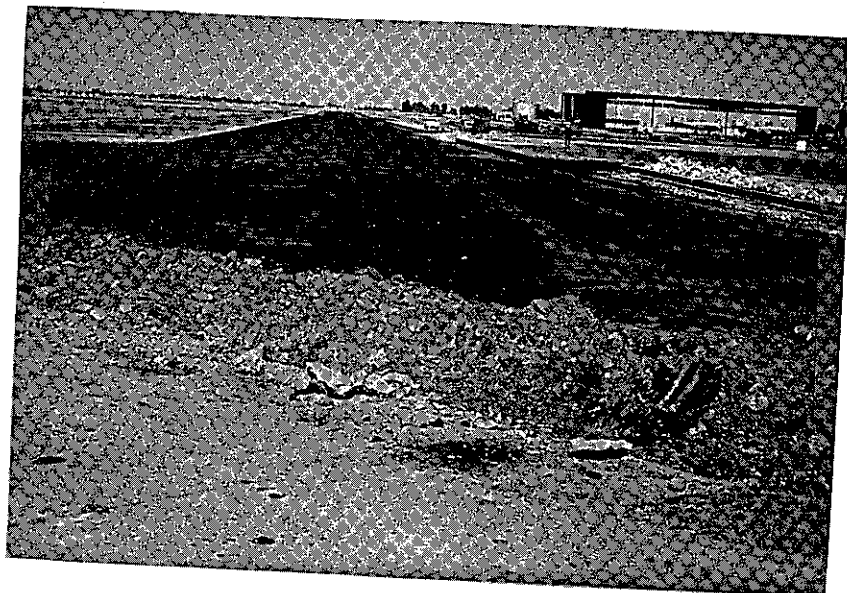
Figure B-30. Taxiway; another view showing wet spots on base course several days after a rain.

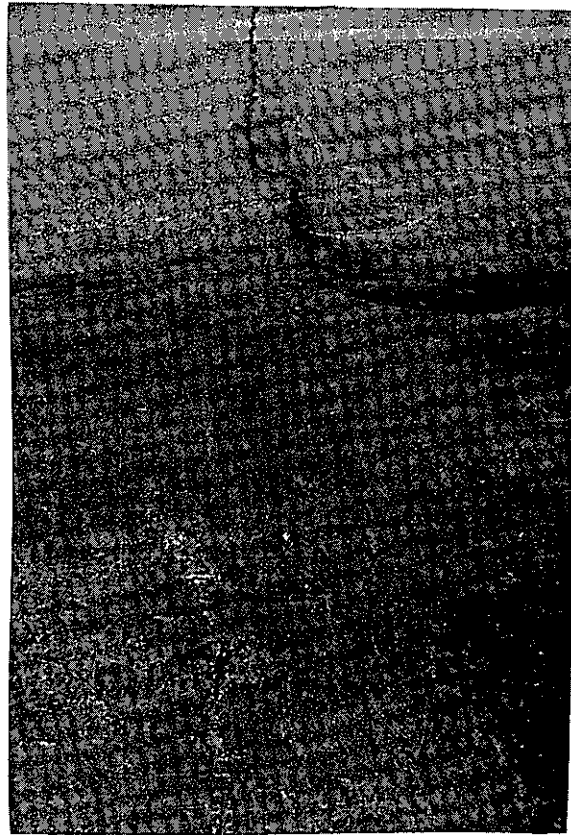
Figure B-31. Parking apron; reflection cracks in 2-in. tar-rubber overlay on 16-in. PCC.

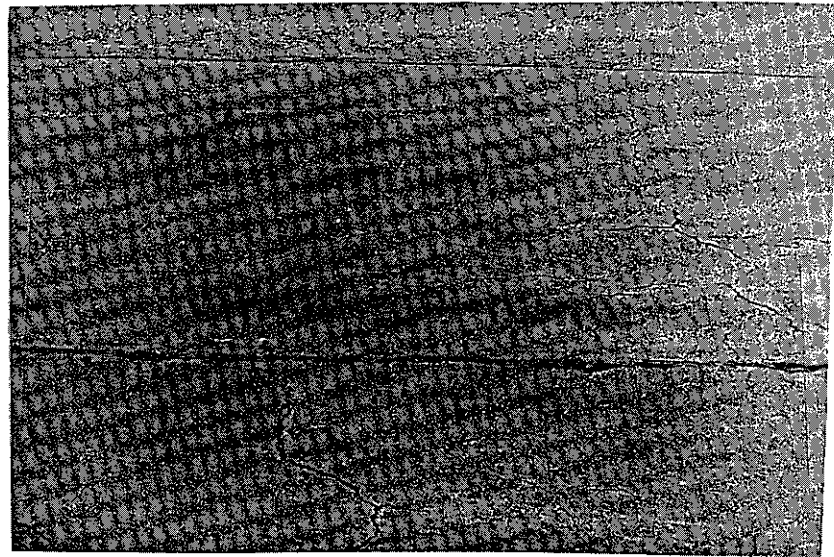
Figure B-32. Parking apron; reflection cracking in 7-in. AC overlay on 8-in. PCC.

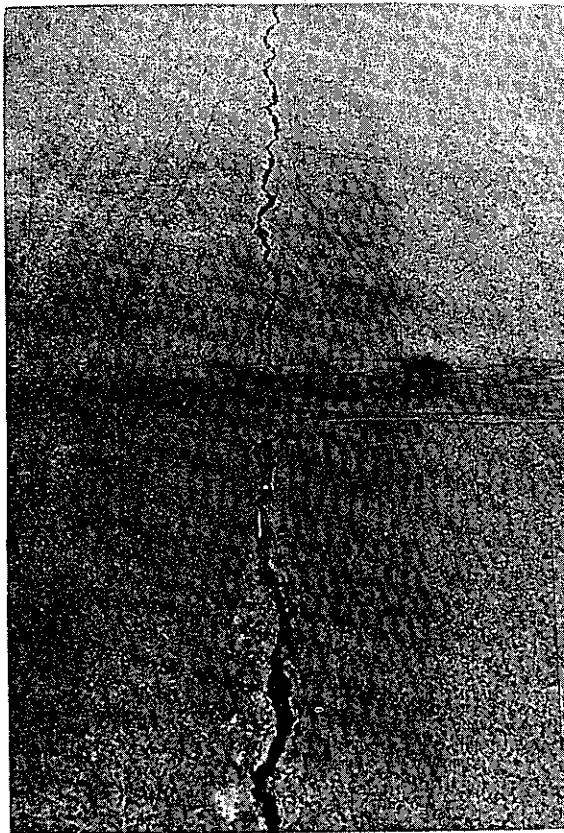
Figure B-33. Parking apron; cracks coming through tar-rubber overlay.

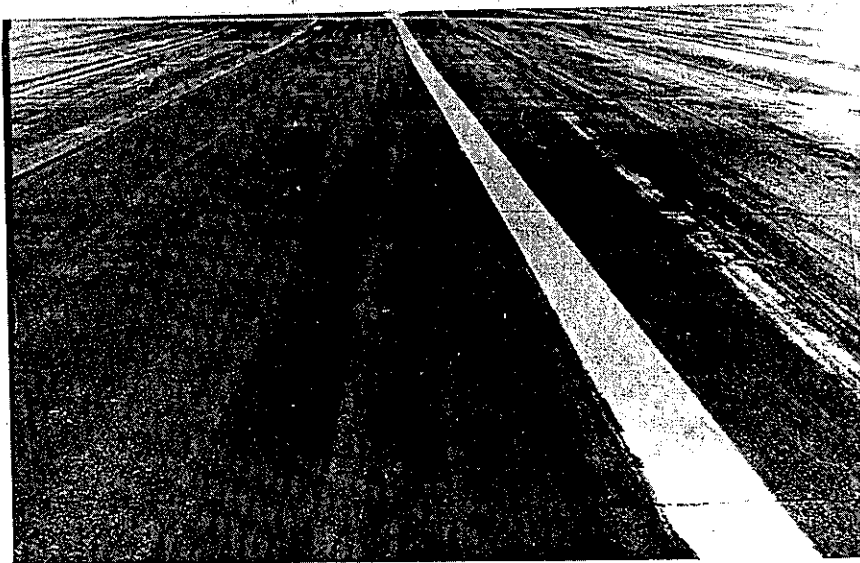
Figure B-34. Extensive reflection cracking in 2-1/2 inch AC overlay on PCC pavement.

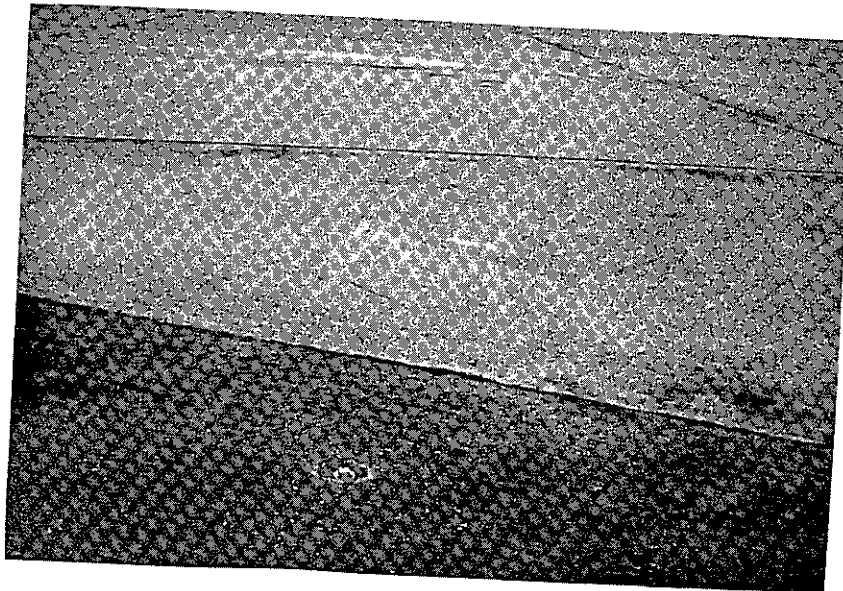
Figure C-5. Cross view of Wells 4 and 5; shows general appearance shortly after installation; Well 4 (near upper center) barely visible; dark stains are signs of surging or bleeding in this area; dry pavement today.

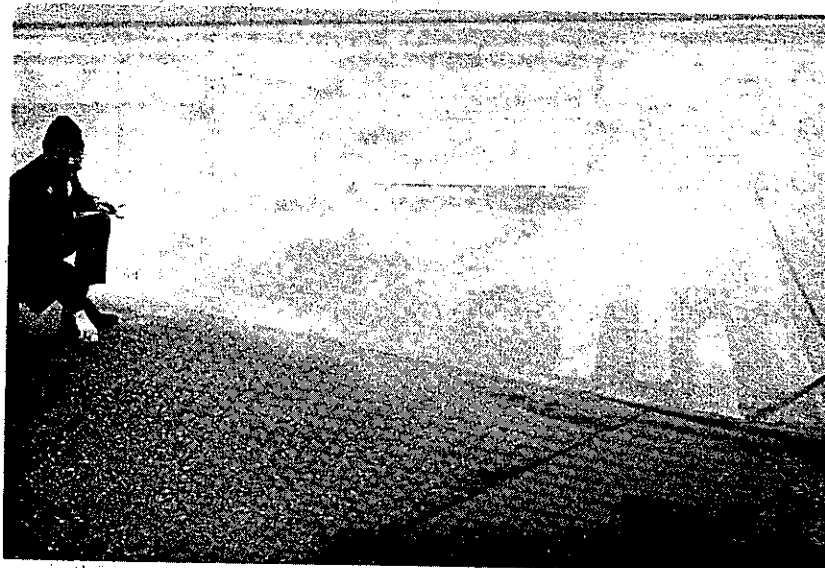
Figure C-14. Cross view at Wells 4 and 5 several hours after a rain; shows wet condition; officer is at Well 5.

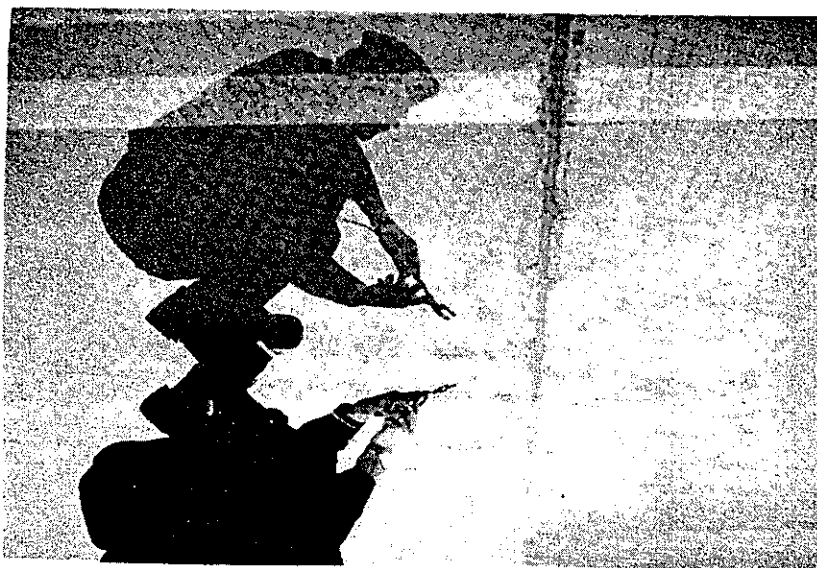
Figure C-15. View at Well 4, same time as Fig. C-14; about 1/2 in. of water over pavement and well.

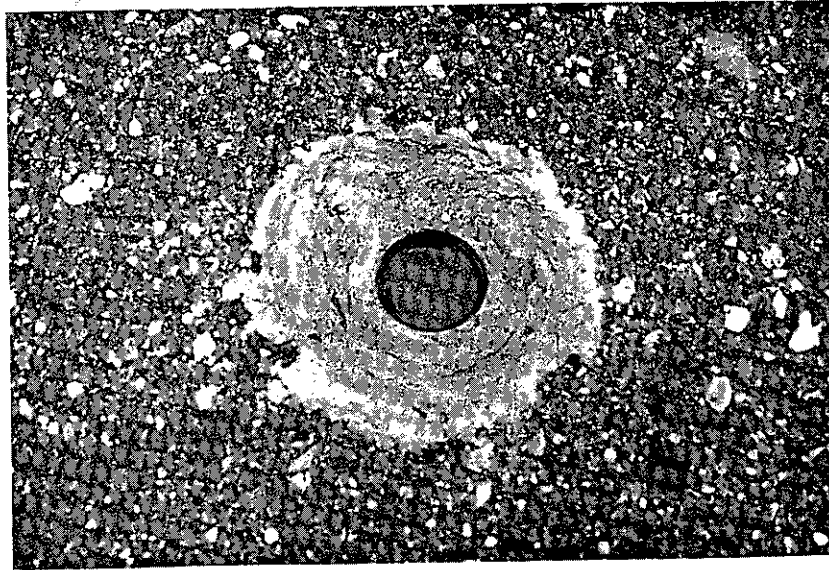
Figure C-16. Close-up of Well 5 several hours after a rain; pavement is damp, but no surface water; hydrostatic head in base raised water to 1 in. from top of pavement.

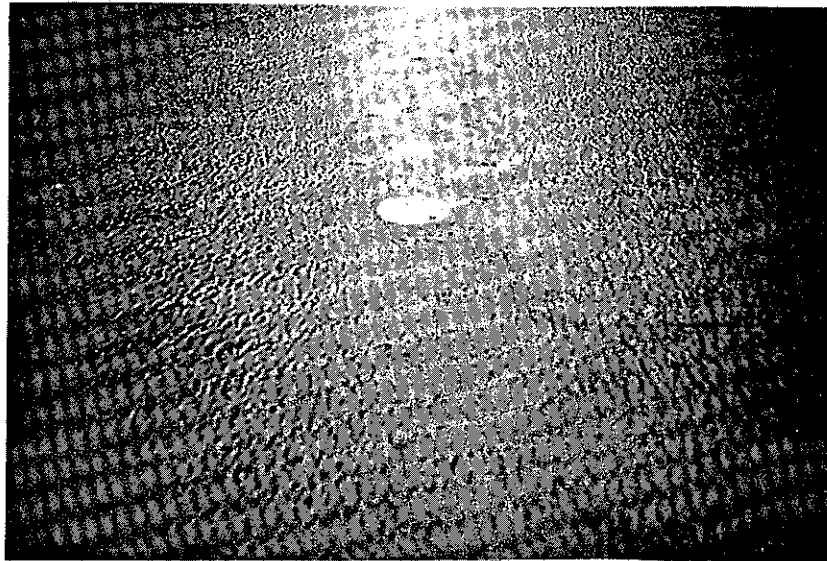
Figure C-17. View at Well 8 during a rain; very poor surface drainage here; much water collects on surface; subsurface drainage also very slow; 1/2 in. of water over surface, strong current; strong light reflection off water.

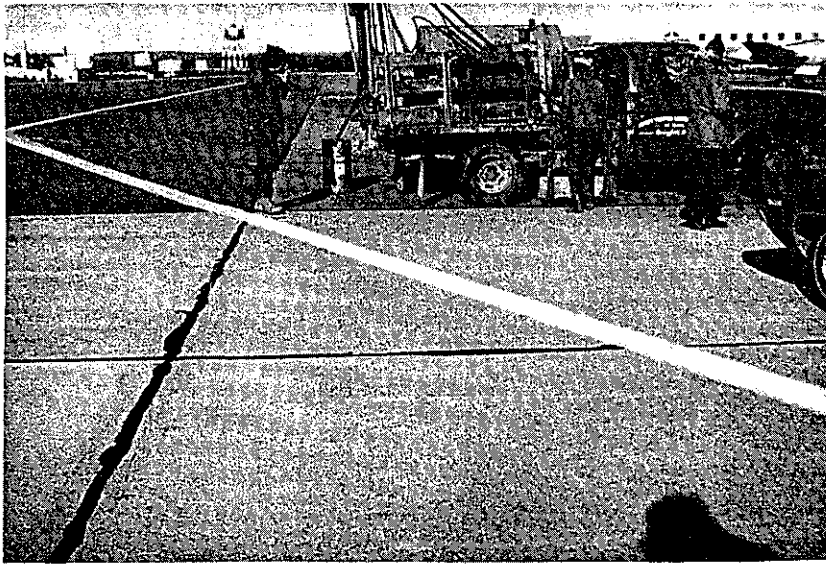
Figure D-4. View of drilling equipment at Well 6; is in 20-in. thick PCC at SW Warm-up Apron and Taxiway; dark stains suggest some bleeding may occur here; no excess water at time of drilling.

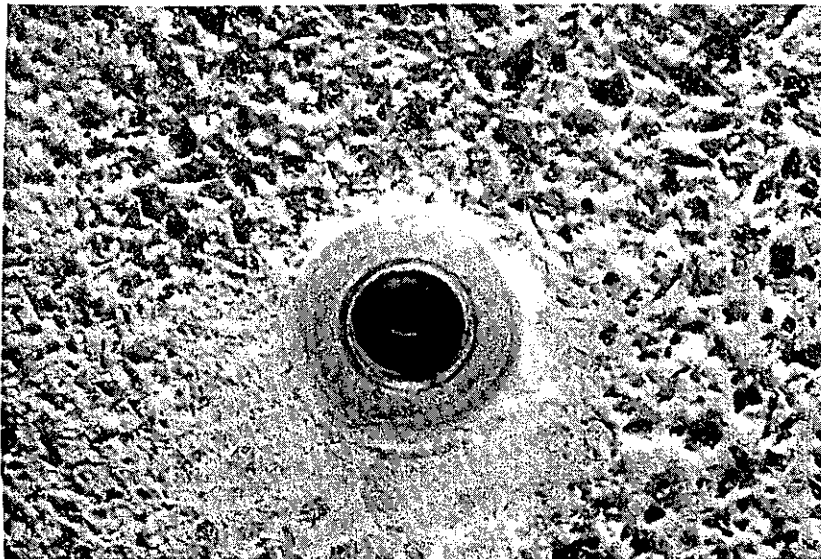
Figure D-9. Looking down into Well 6, falling head permeability test in progress; water in well has fallen to 4.5 inches below top of pavement after 6 minutes; average k is about 7×10^{-5} cm/sec (0.2 ft/day).

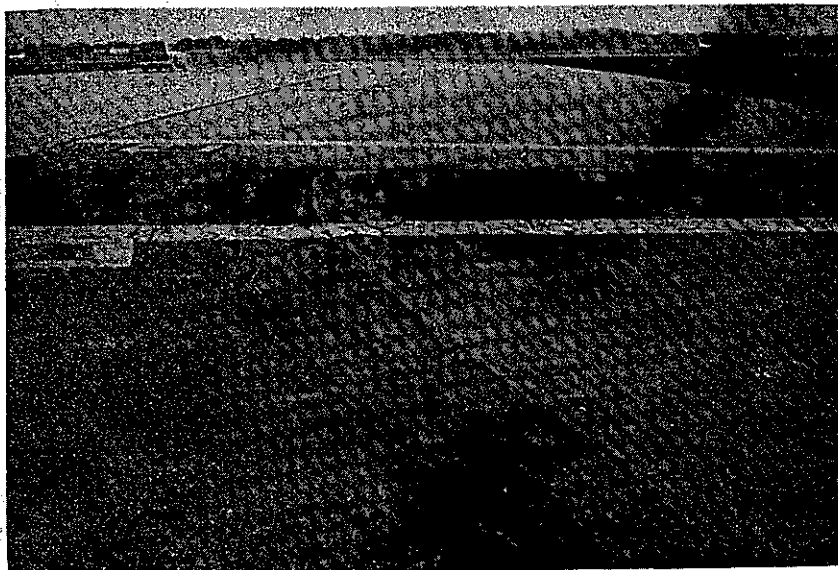
Figure E-11. Looking toward site of Wells 1-4 in Taxiway 14; deteriorated shoulder in foreground, has been damaged from excess water and frost action; the wells were installed later in vicinity of vehicle.

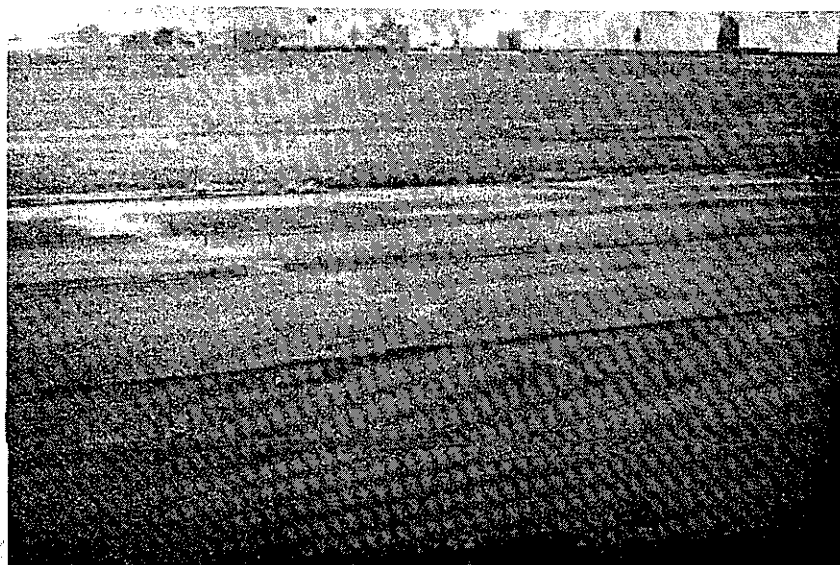
Figure E-12. Photo shows bleeding stains near site of Well 10 (which was installed later near edge of pavement); well develops small artesian pressure after rains.

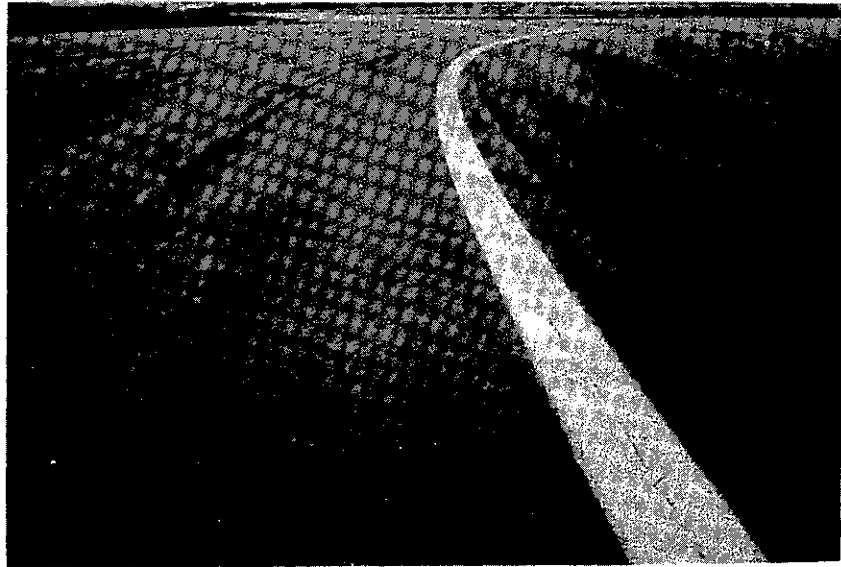
Figure E-13. Photo of NE Warm-up Apron near site of Wells 9 and 10 (installed later); crown area appears to drain rather rapidly, lower edge does not; Well 9 was drilled near the crown, Well 10 near far left edge; photo taken 9-1-72; wells drilled 10-18-72.

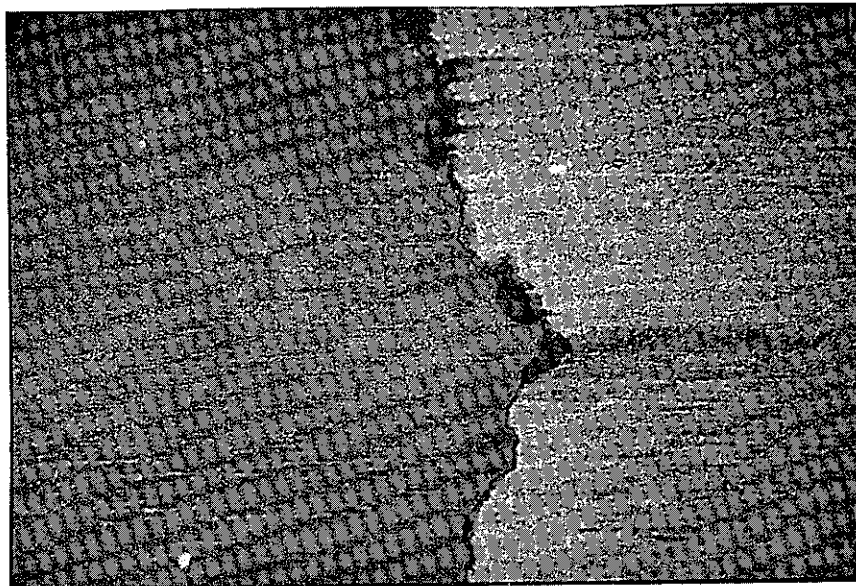
Figure F-5. Open shrinkage crack in Taxiway B at Exit G; 1969 construction.

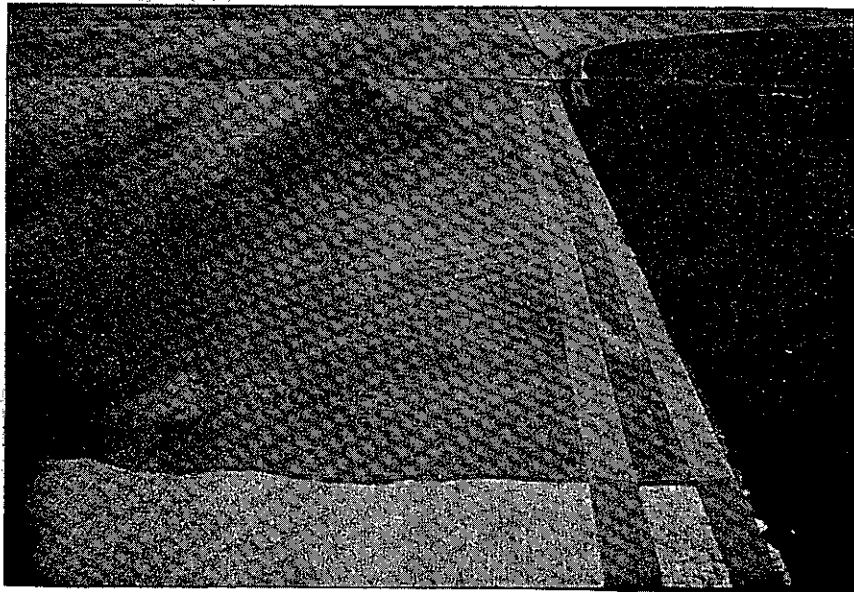
Figure F-6. Shows water entering into cracks and joints in 1969 construction; Taxiway B at Holding Apron.

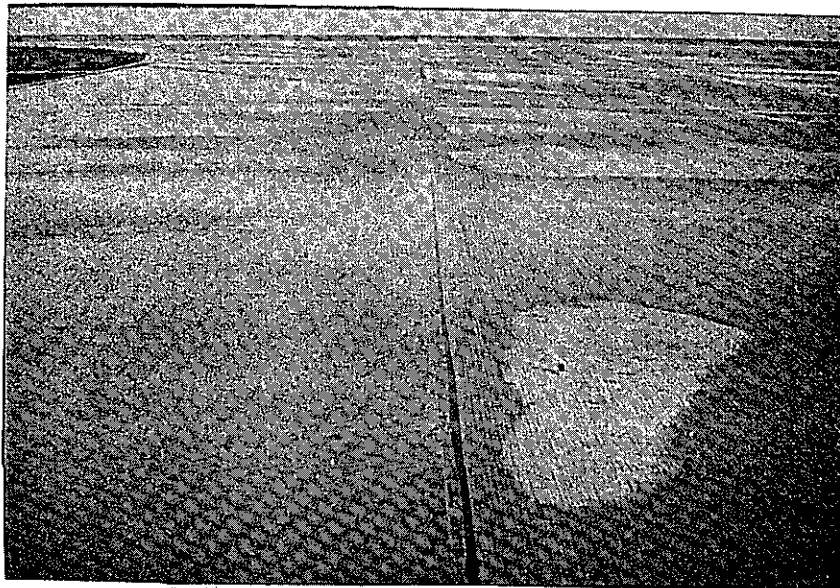
Figure F-7. Shows water standing over a sag in 1969 taxiway; Taxiway B Exit at Holding Apron; may indicate slower drainage than at most areas.
